Royal Windsor

The Castle Reassessed

Steven Brindle and Brian Kerr

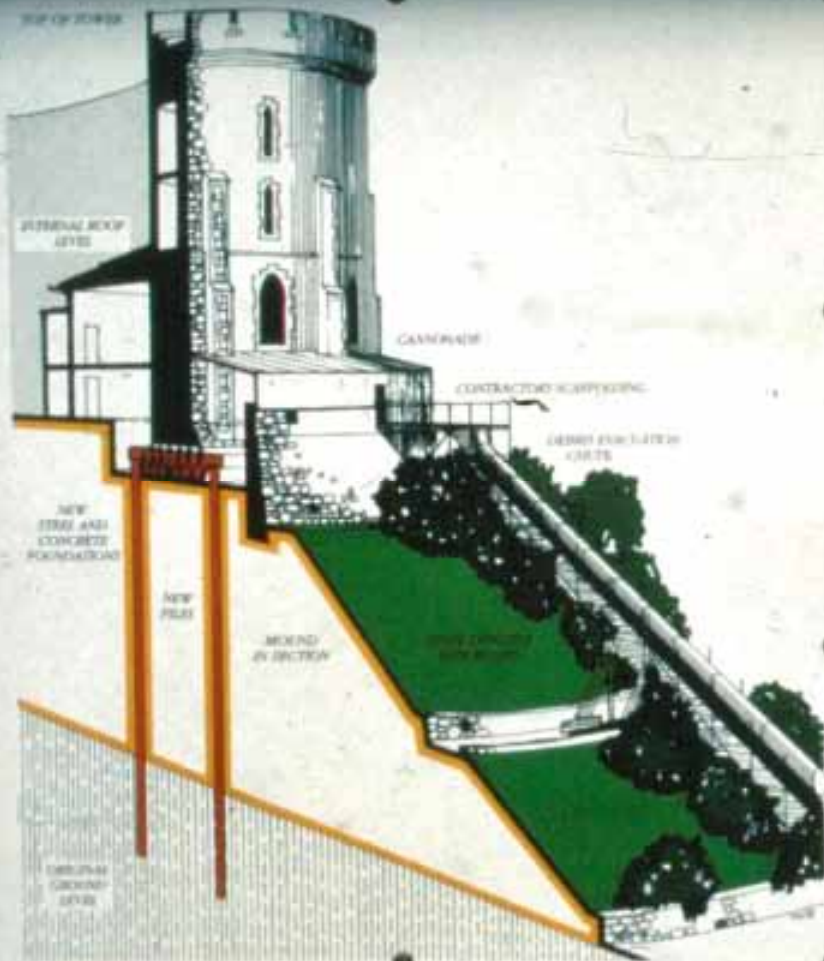
CURRENT WORK TO THE ROUND TOWER

A part of the mound was found to have slipped following the increasingly wet season of 1967/68. This man-made chalk embankment was raised during 1973 on a national emergency, the stone walls replacing timber a hundred years later.

The tower structure is therefore being stabilised by driving a series of 84 piles of 600mm diameter 22 metres deep around the perimeter walls both inside and out.

The piles, in turn, will support new steel and concrete foundations inserted under the keep walls at cannonade level.

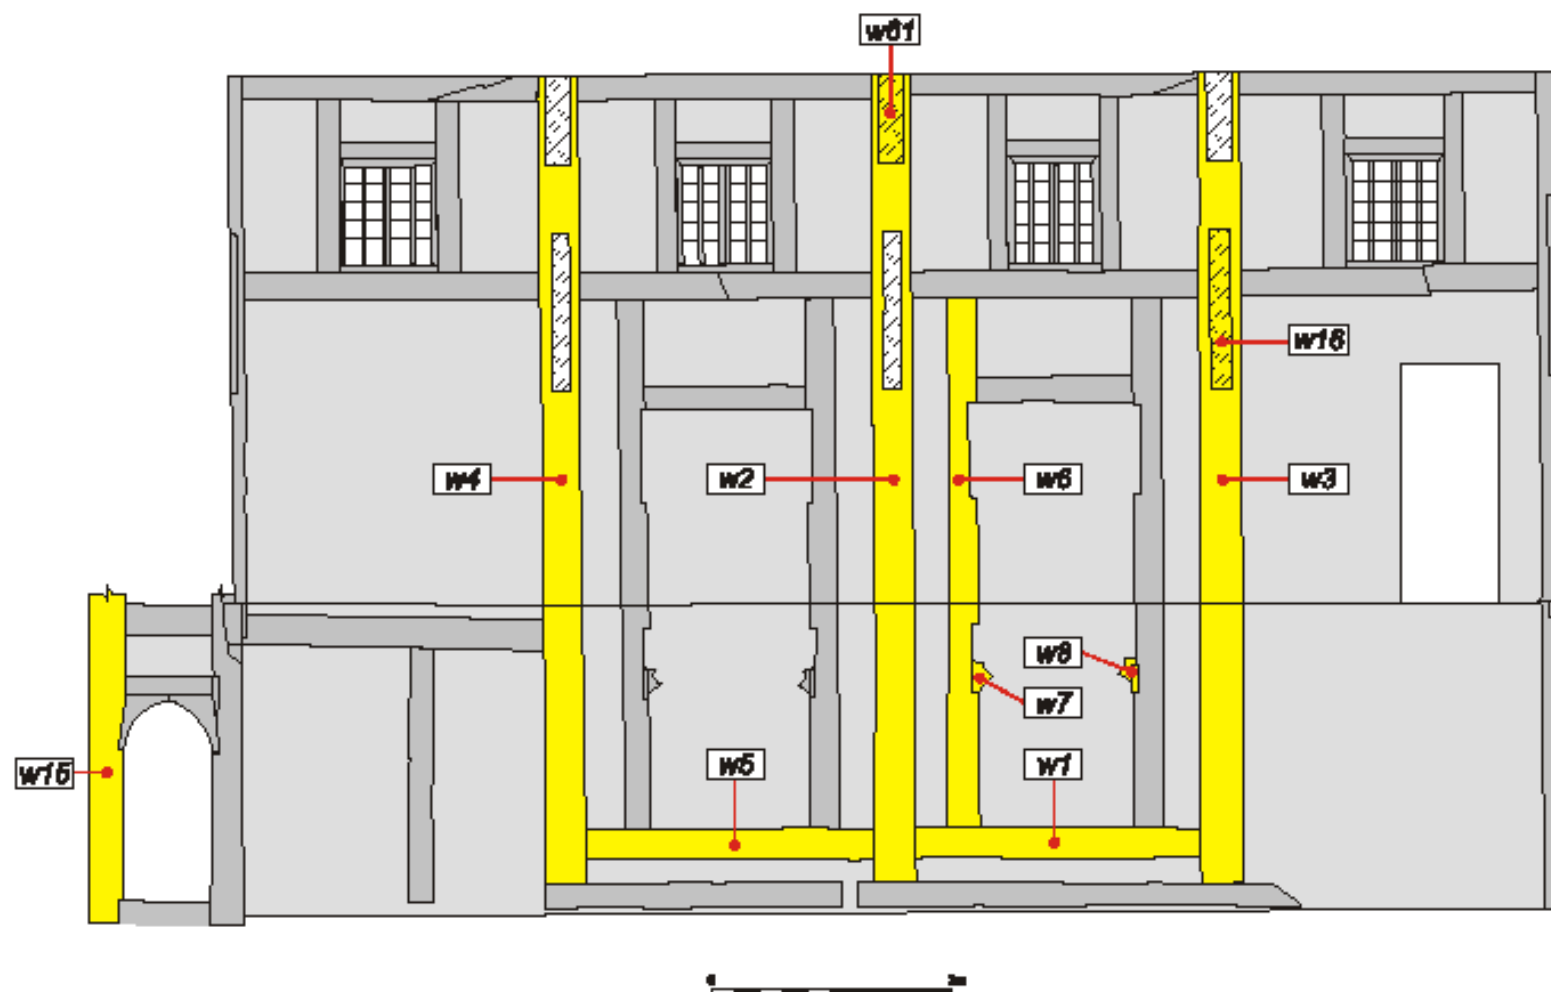
Figure 12. West face of east wall of original hall (*Centre for Archaeology*)

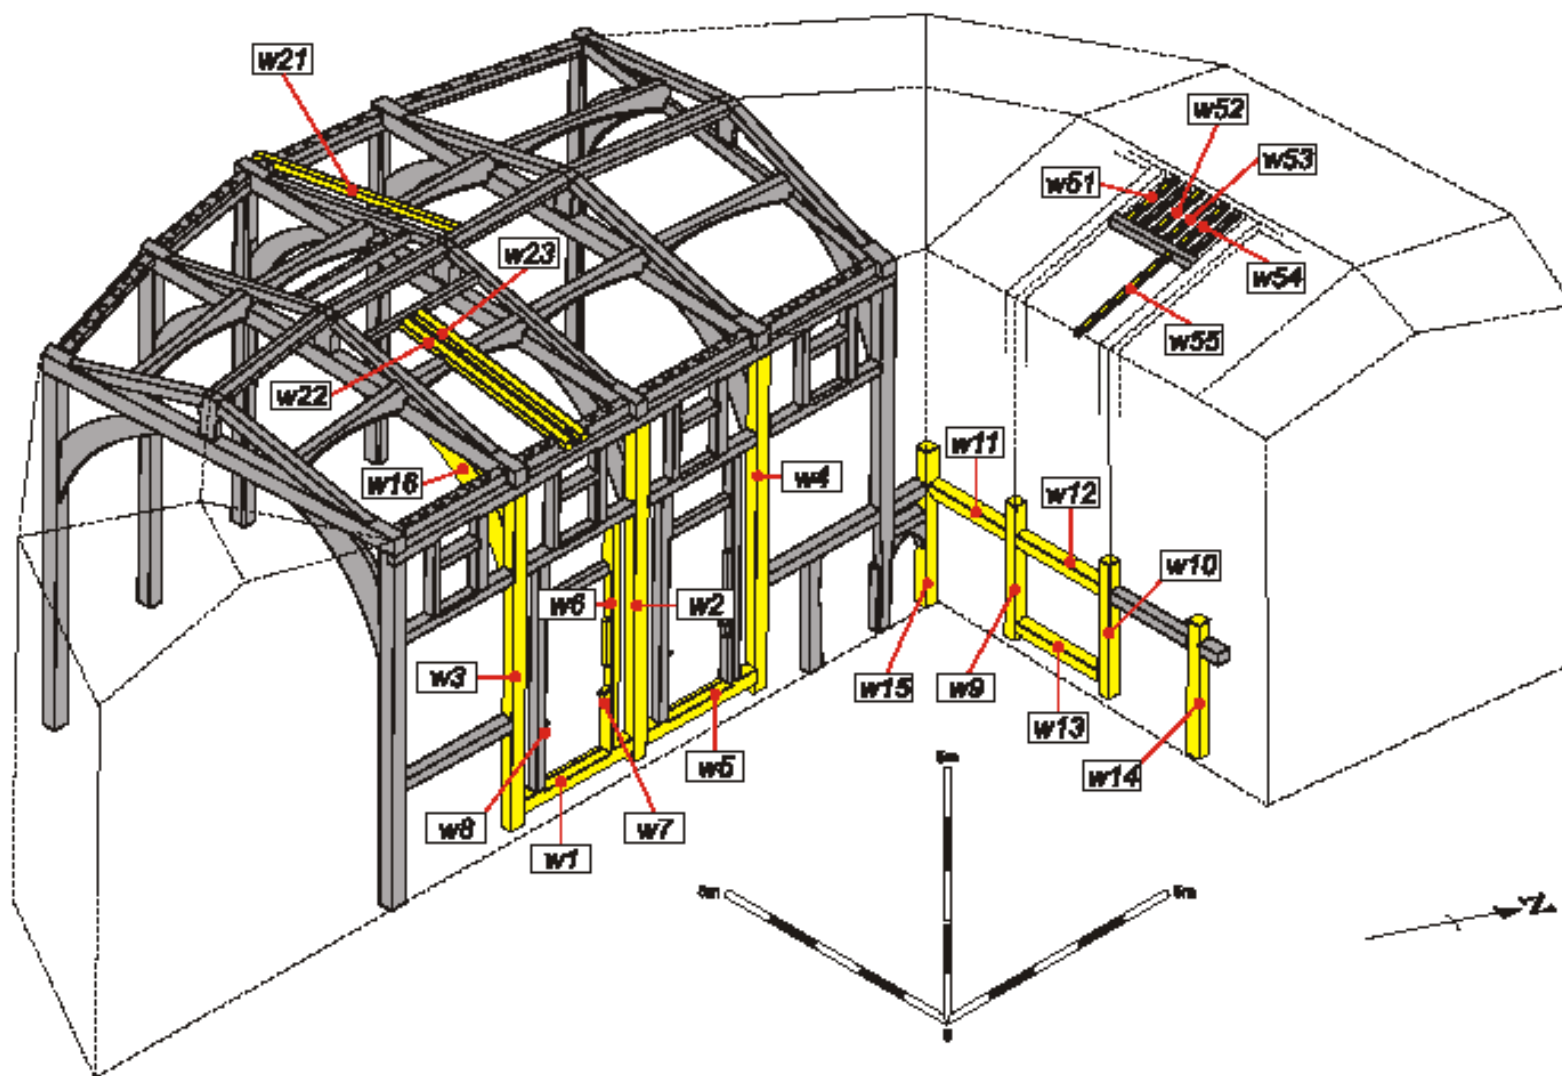
Figure 11. View of hall and kitchen range from courtyard (*Centre for Archaeology*)

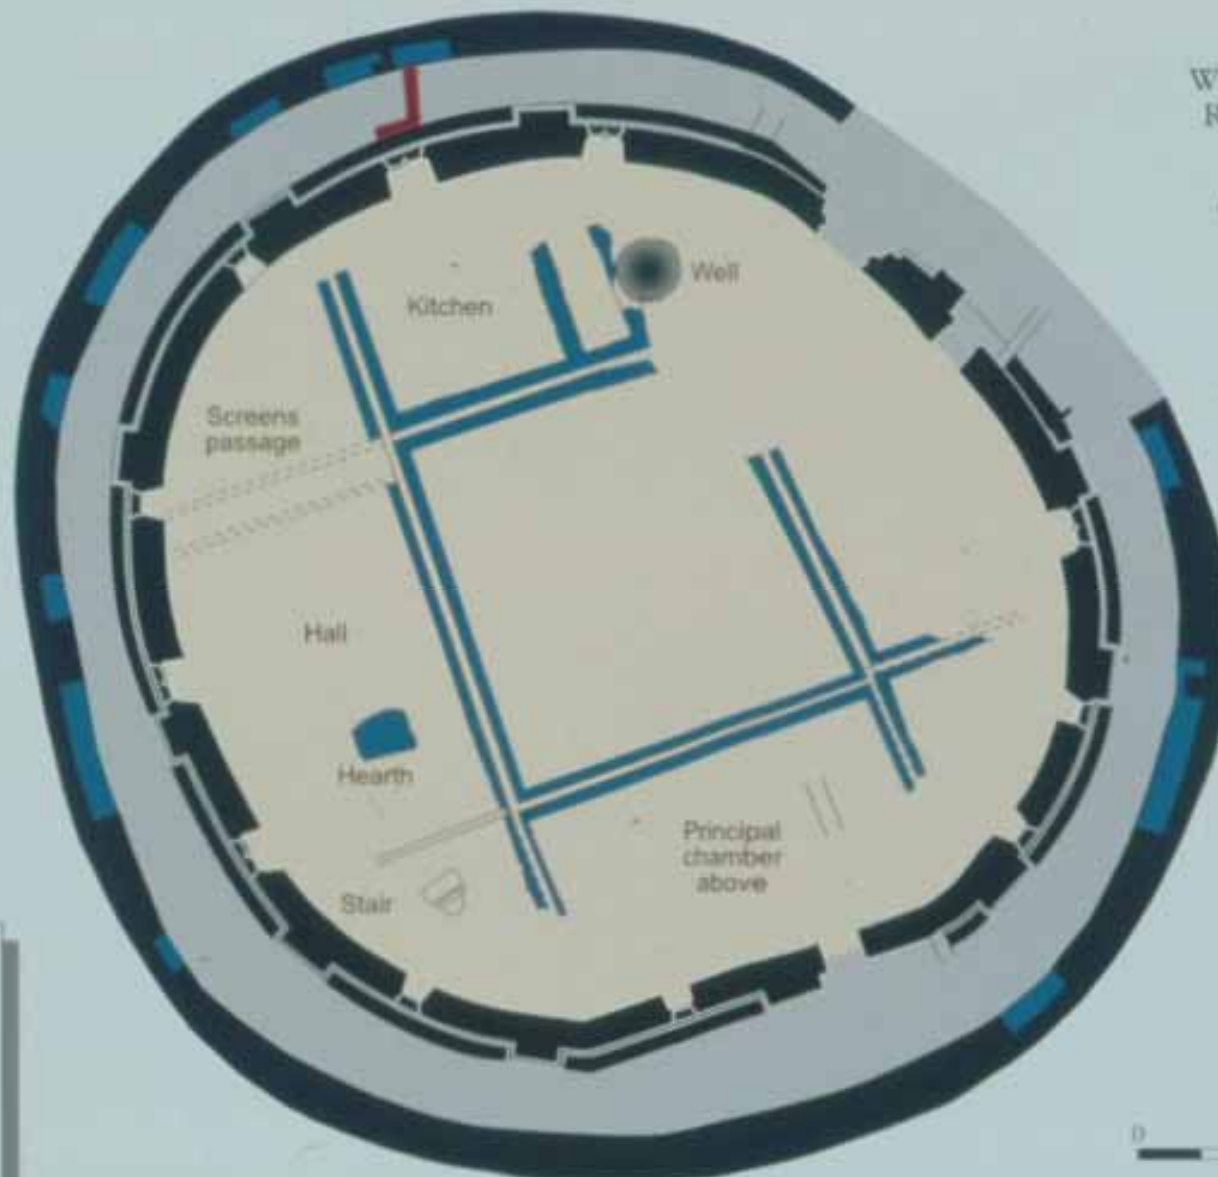
Windsor Castle
Round Tower

Phase 5
c.1354-1361

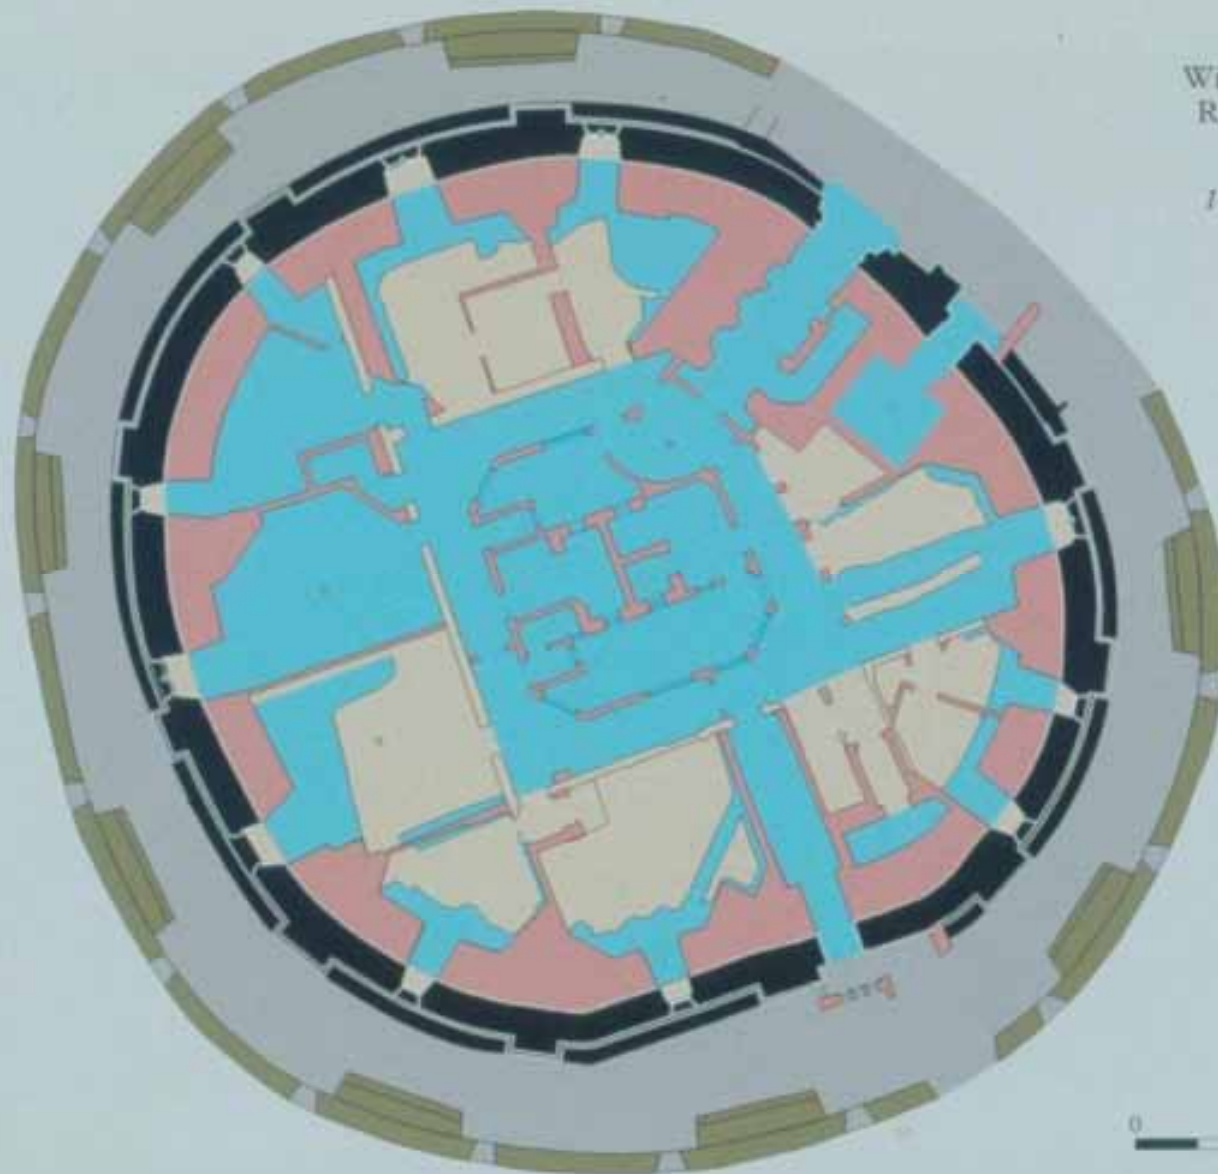
Windsor Castle
Round Tower

Phase 7
1830/31-1989

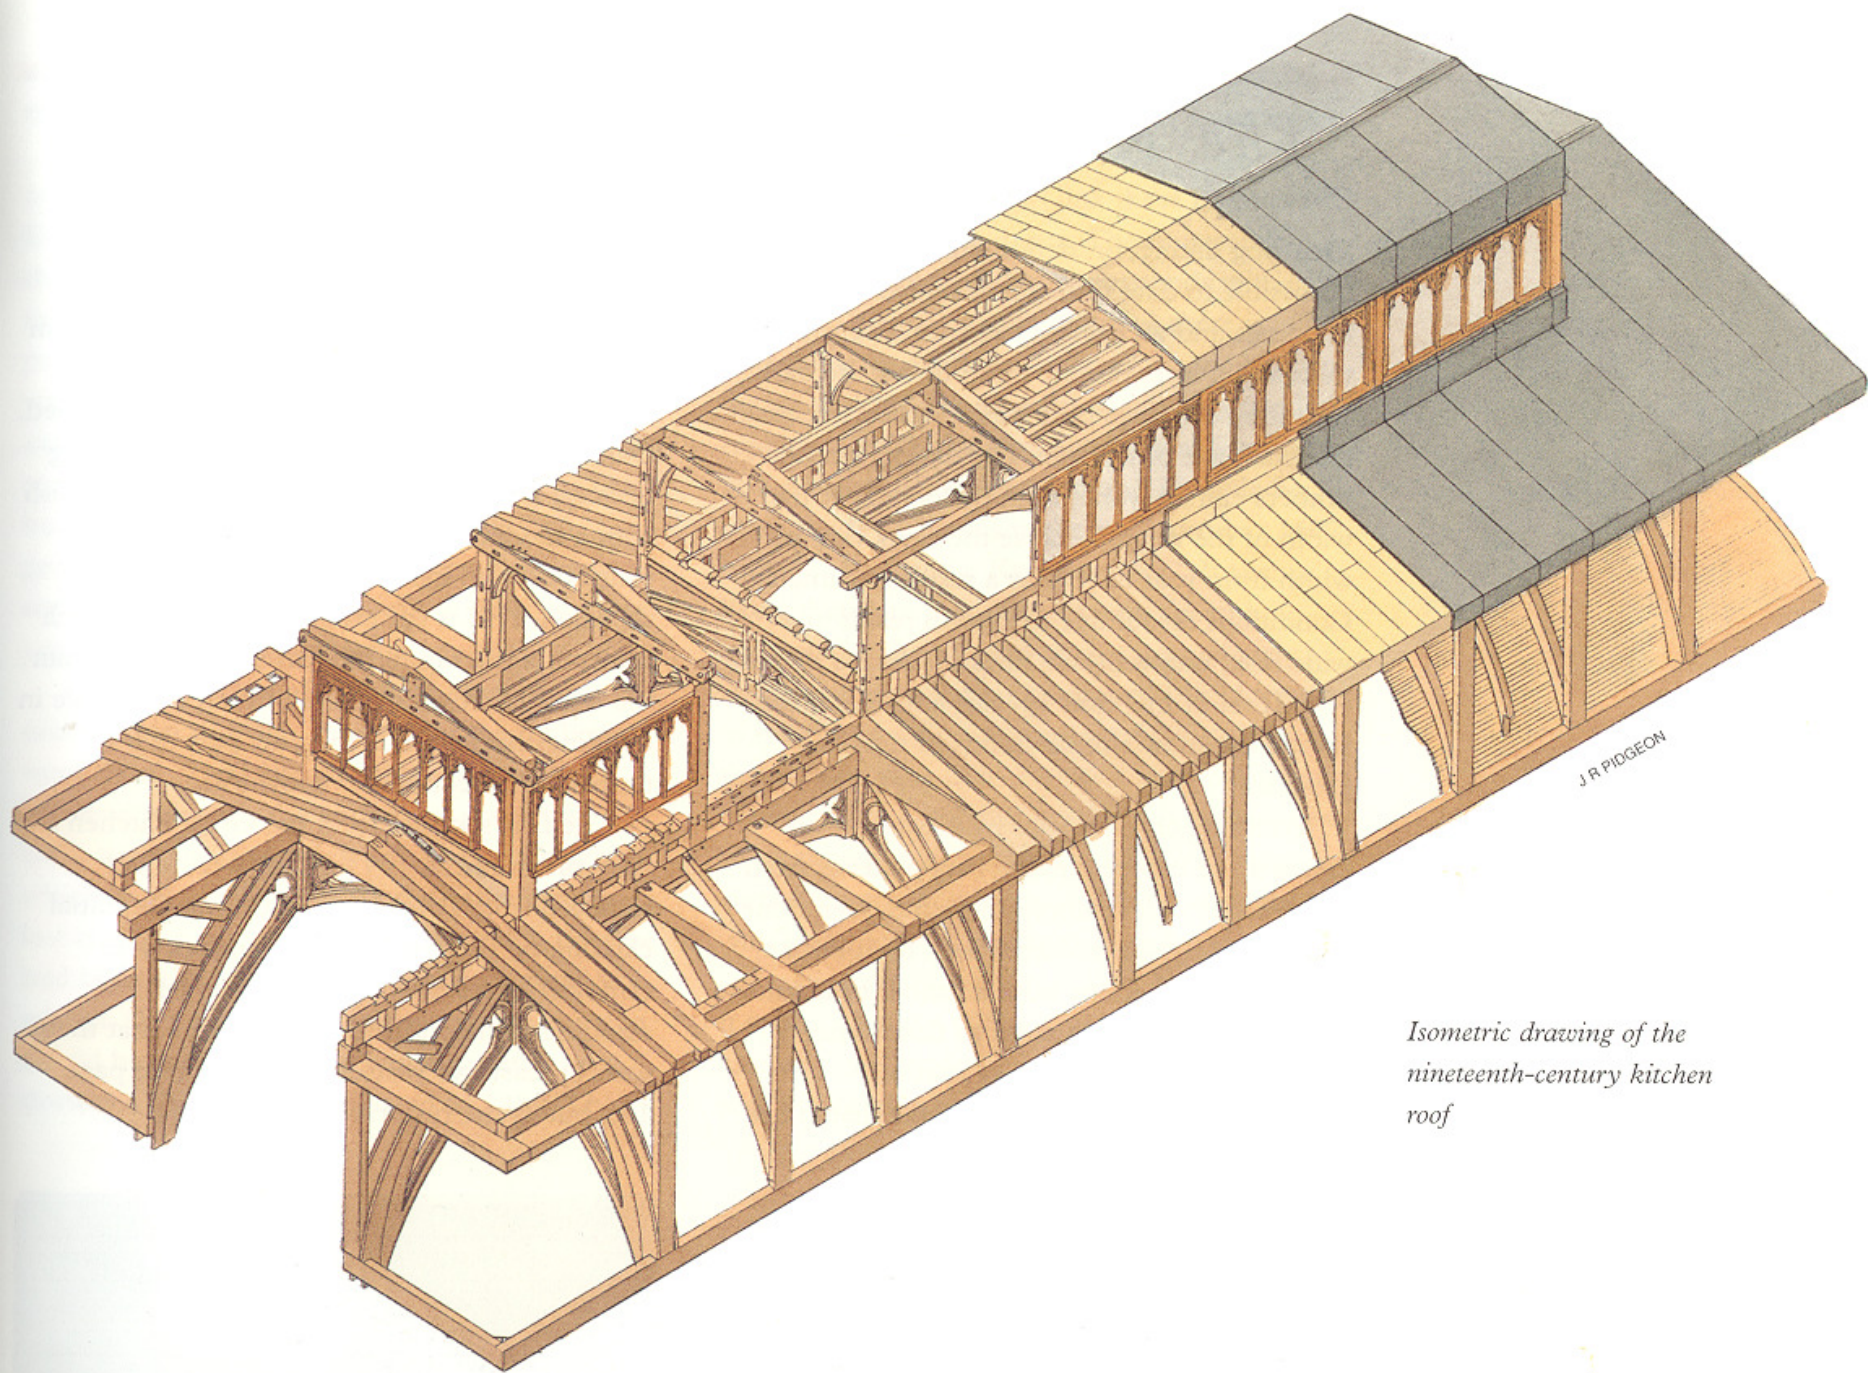
*Isometric drawing of the
nineteenth-century kitchen
roof*

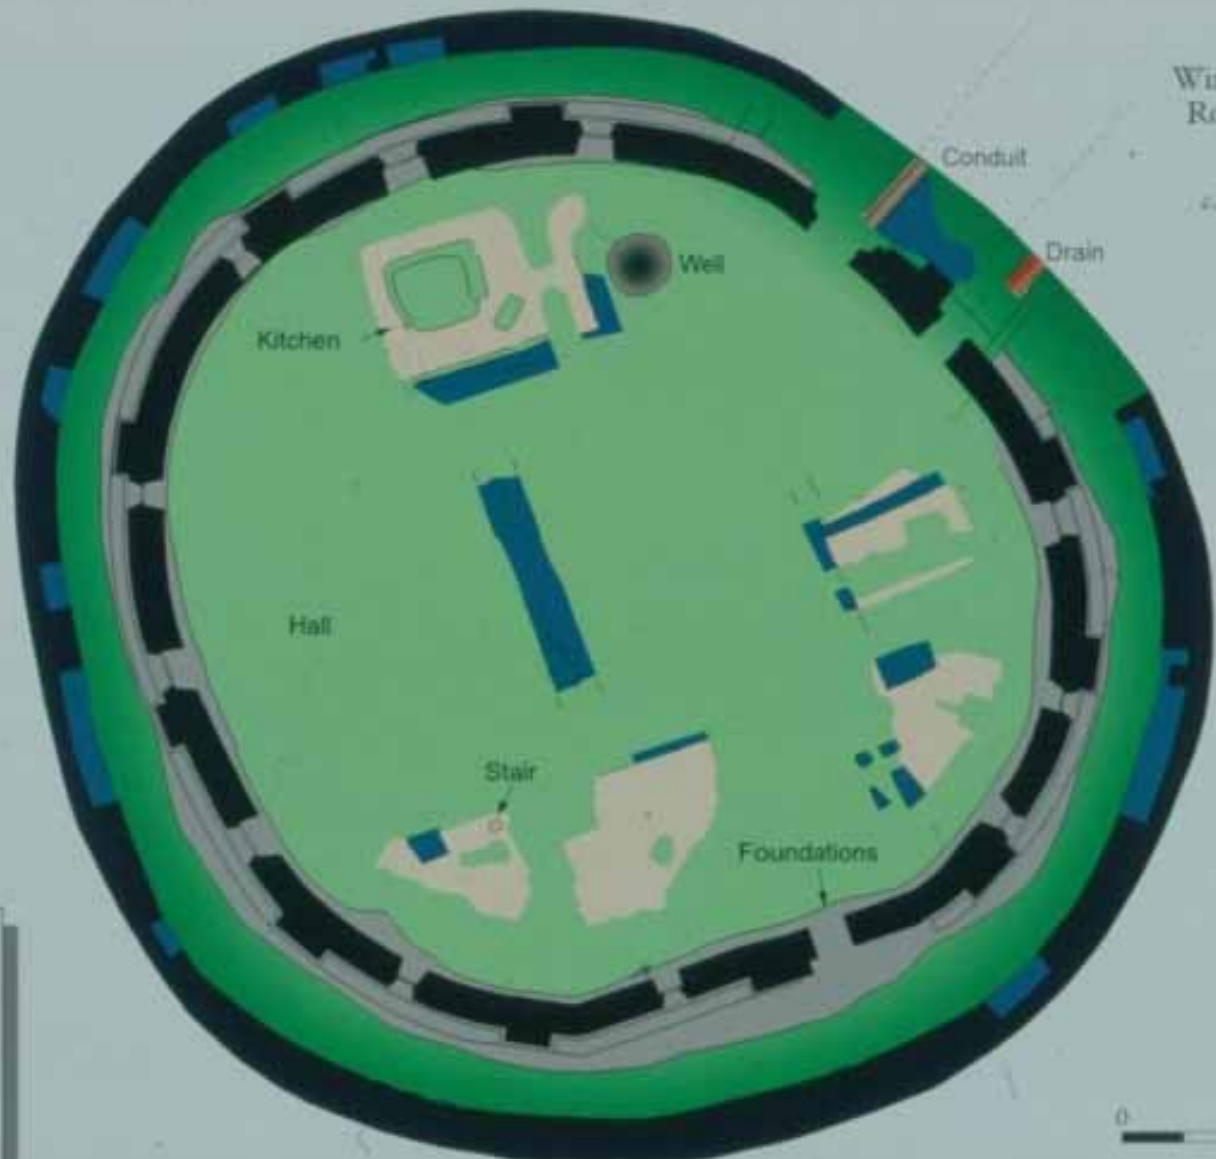
Windsor Castle Round Tower

Phase 4
c.1170-1350
