**Britford, Wiltshire: archaeology and history** (summary for visitors prepared by the Royal Archaeological Institute, 2017)

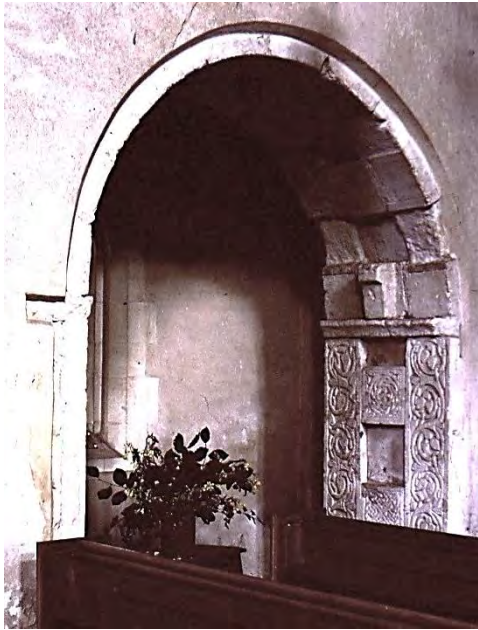
BRITTFORD.  
N. Archway - E. Jamb.  
Fig. 9. North Archway. East Jamb.

The arrangement of carved stone slabs and panels in the entrance to the Anglo-Saxon north porticus is unique. Its east jamb has a vertical slab on each side, carved with a running vinescroll plant, with square panels of knotwork set into the recessed central area. The west jamb also has vertical panels, now plain

but perhaps originally painted if not cut back, removing any sculpture. It has one panel carved with knotwork, and one plain one. Above the slabs is a horizontal impost, plain on the west and carved on the east, above which are corbels implying that a horizontal timber beam spanned the arch; presumably it

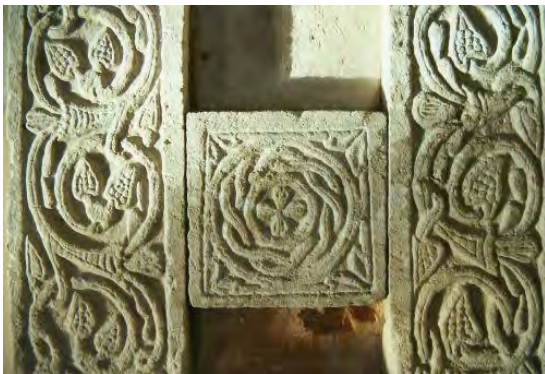
arch above, which is of stone and has a recessed centre and panels, like the jambs.

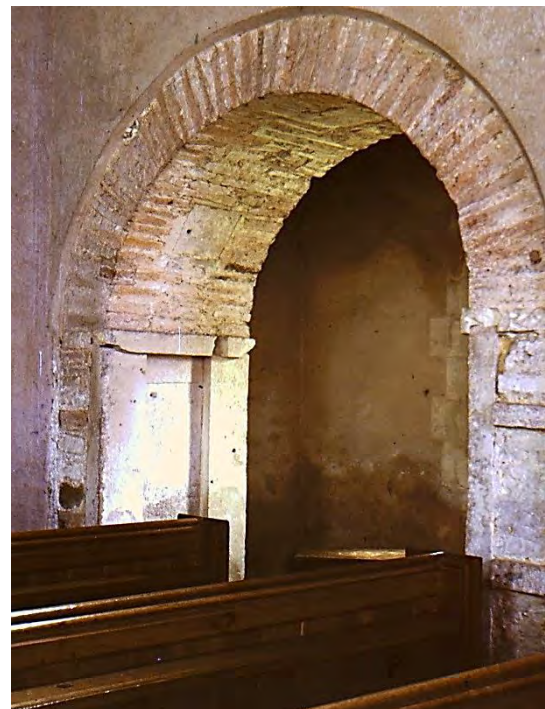
The arch into the south porticus (right) has similar jambs but without any sculpture or panels, no corbels, and a different arch, built out of reused Roman brick – a technique used at Brixworth, Northants., in a phase now attributed to the eighth or ninth century, with the second half of the eighth as likely (Parsons and Sutherland 2010, 232). Both the arches were hidden behind plaster until 1873, so it is likely that some features are missing.
